Infrared Flyover of Middlebury Campus June 4, 2019

In general, whiter colors are warmer, darker colors are cooler. Note however that reflective surfaces, like new metal roofs, register as black thus not representative of the actual heat signature of roof.

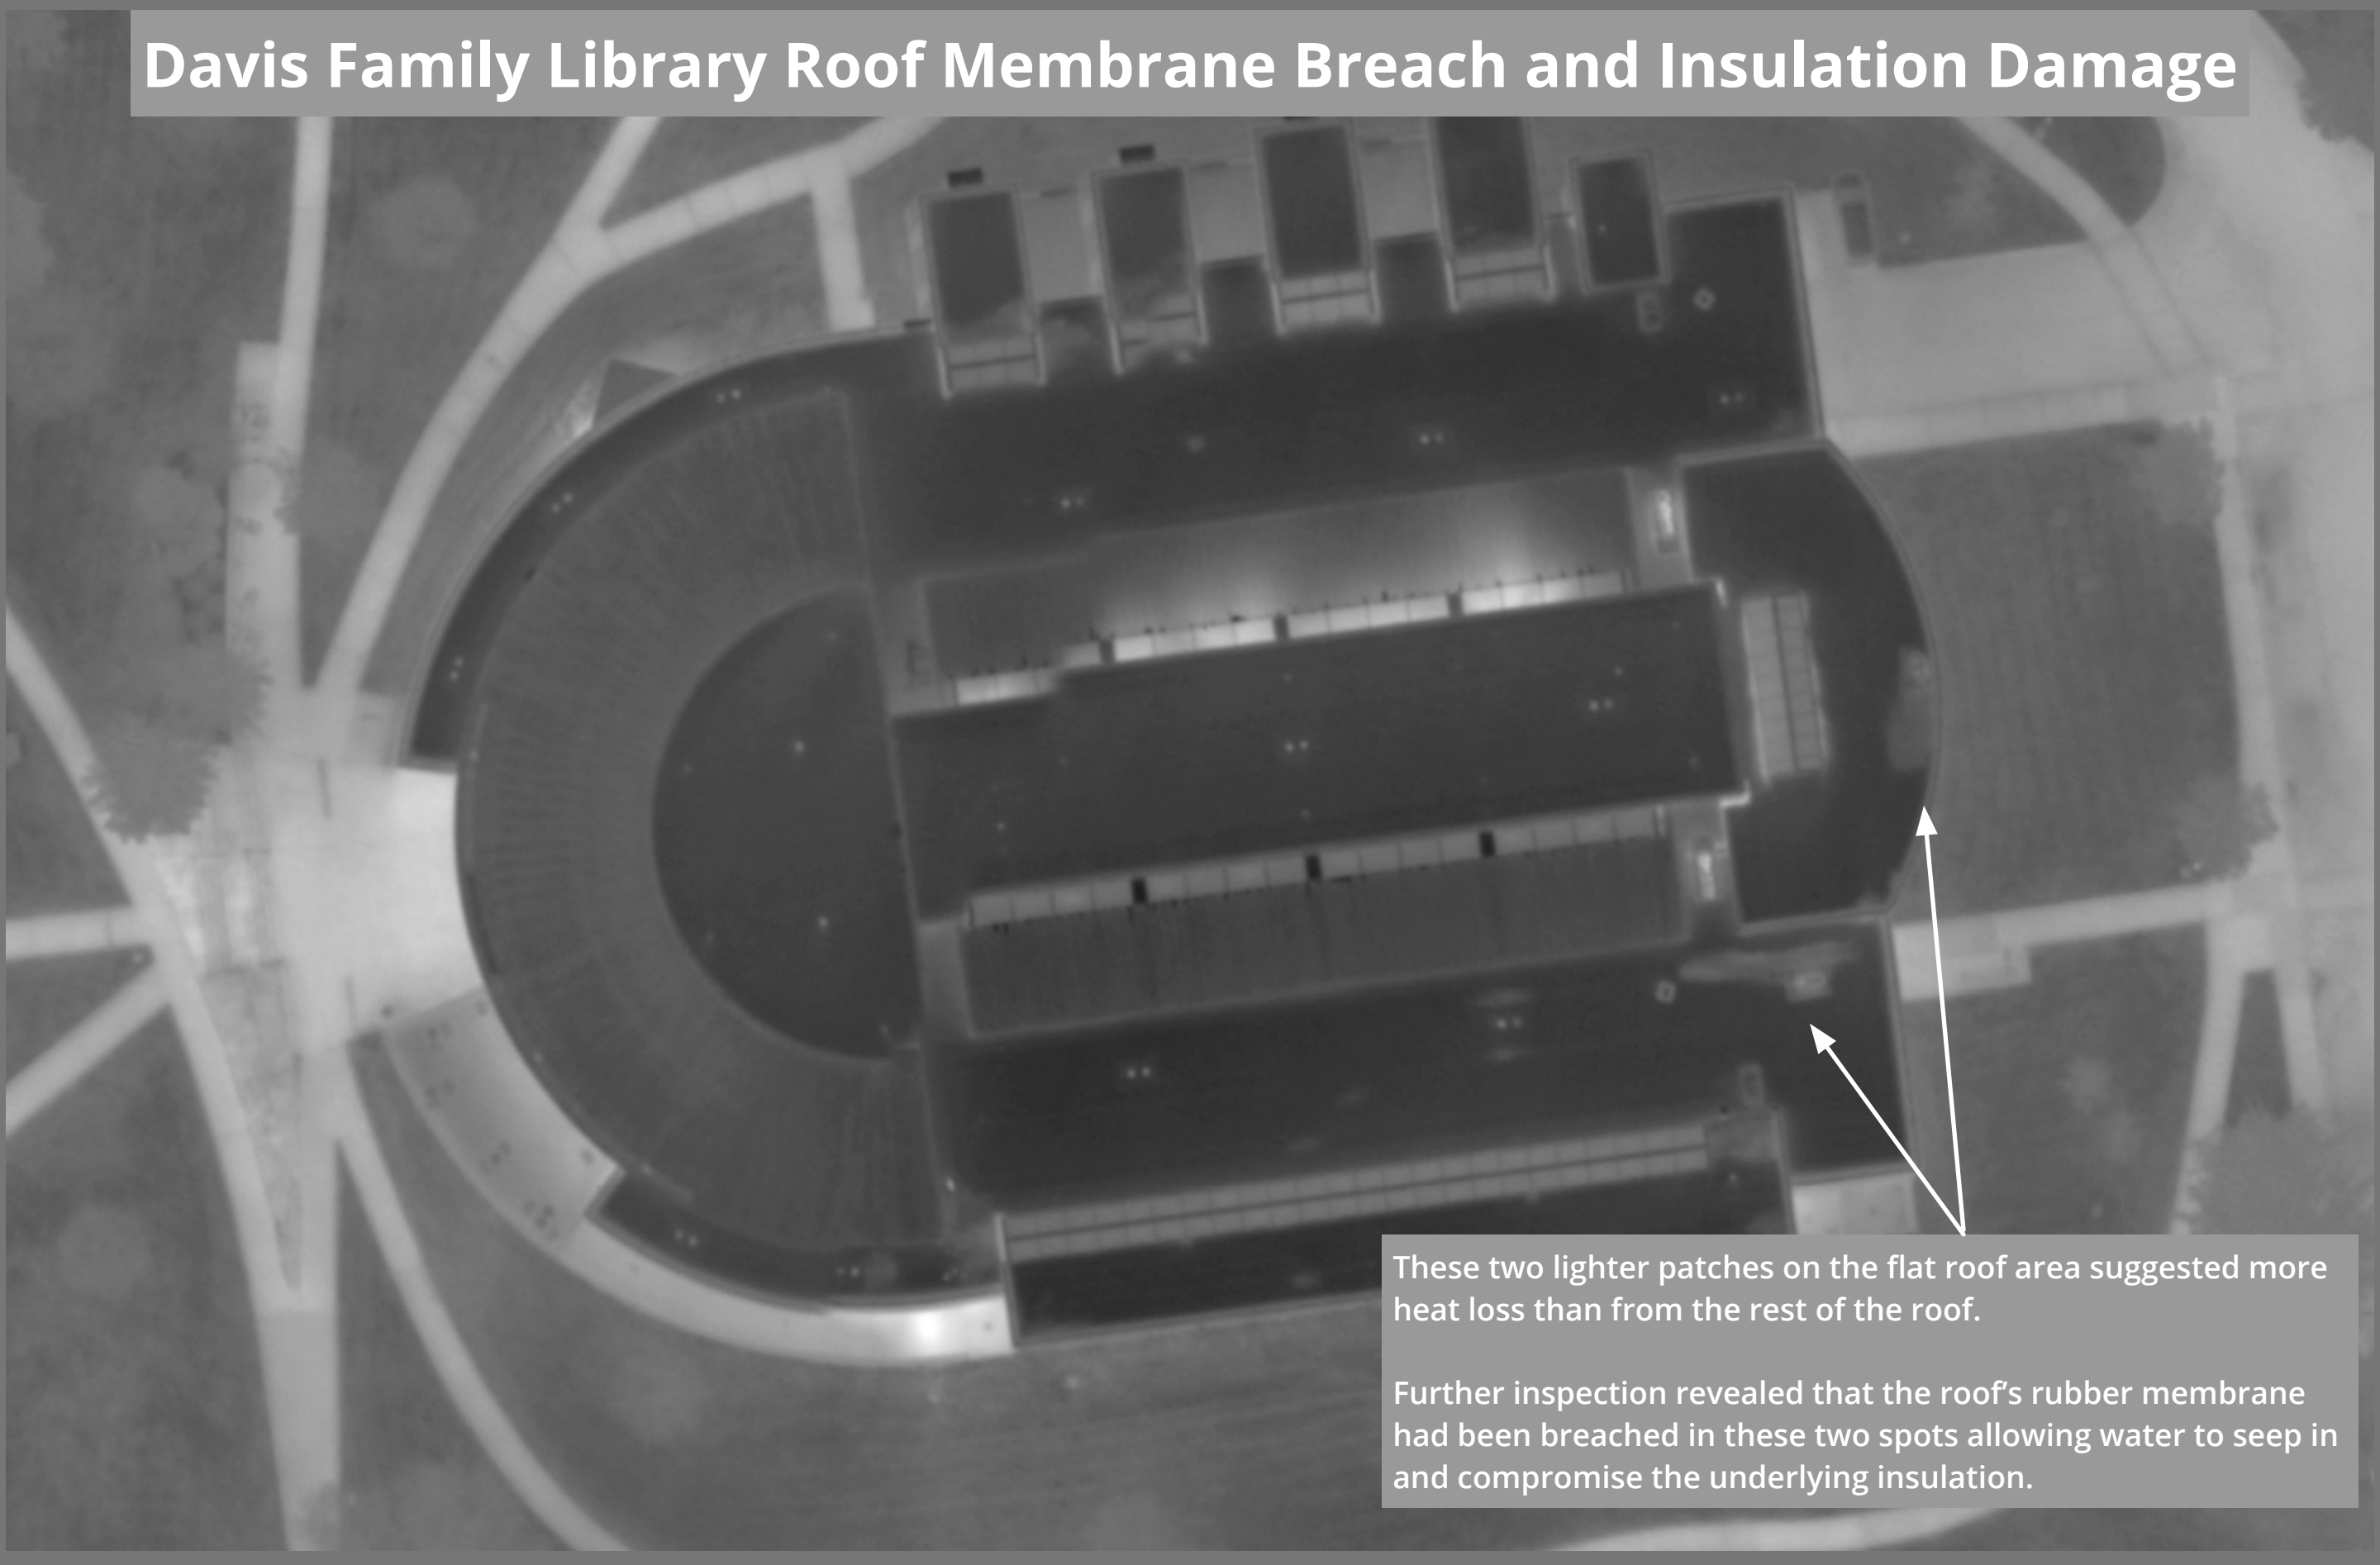
Davis Family Library Roof Membrane Breach and Insulation Damage

These two lighter patches on the flat roof area suggested more heat loss than from the rest of the roof.

Further inspection revealed that the roof's rubber membrane had been breached in these two spots allowing water to seep in and compromise the underlying insulation.

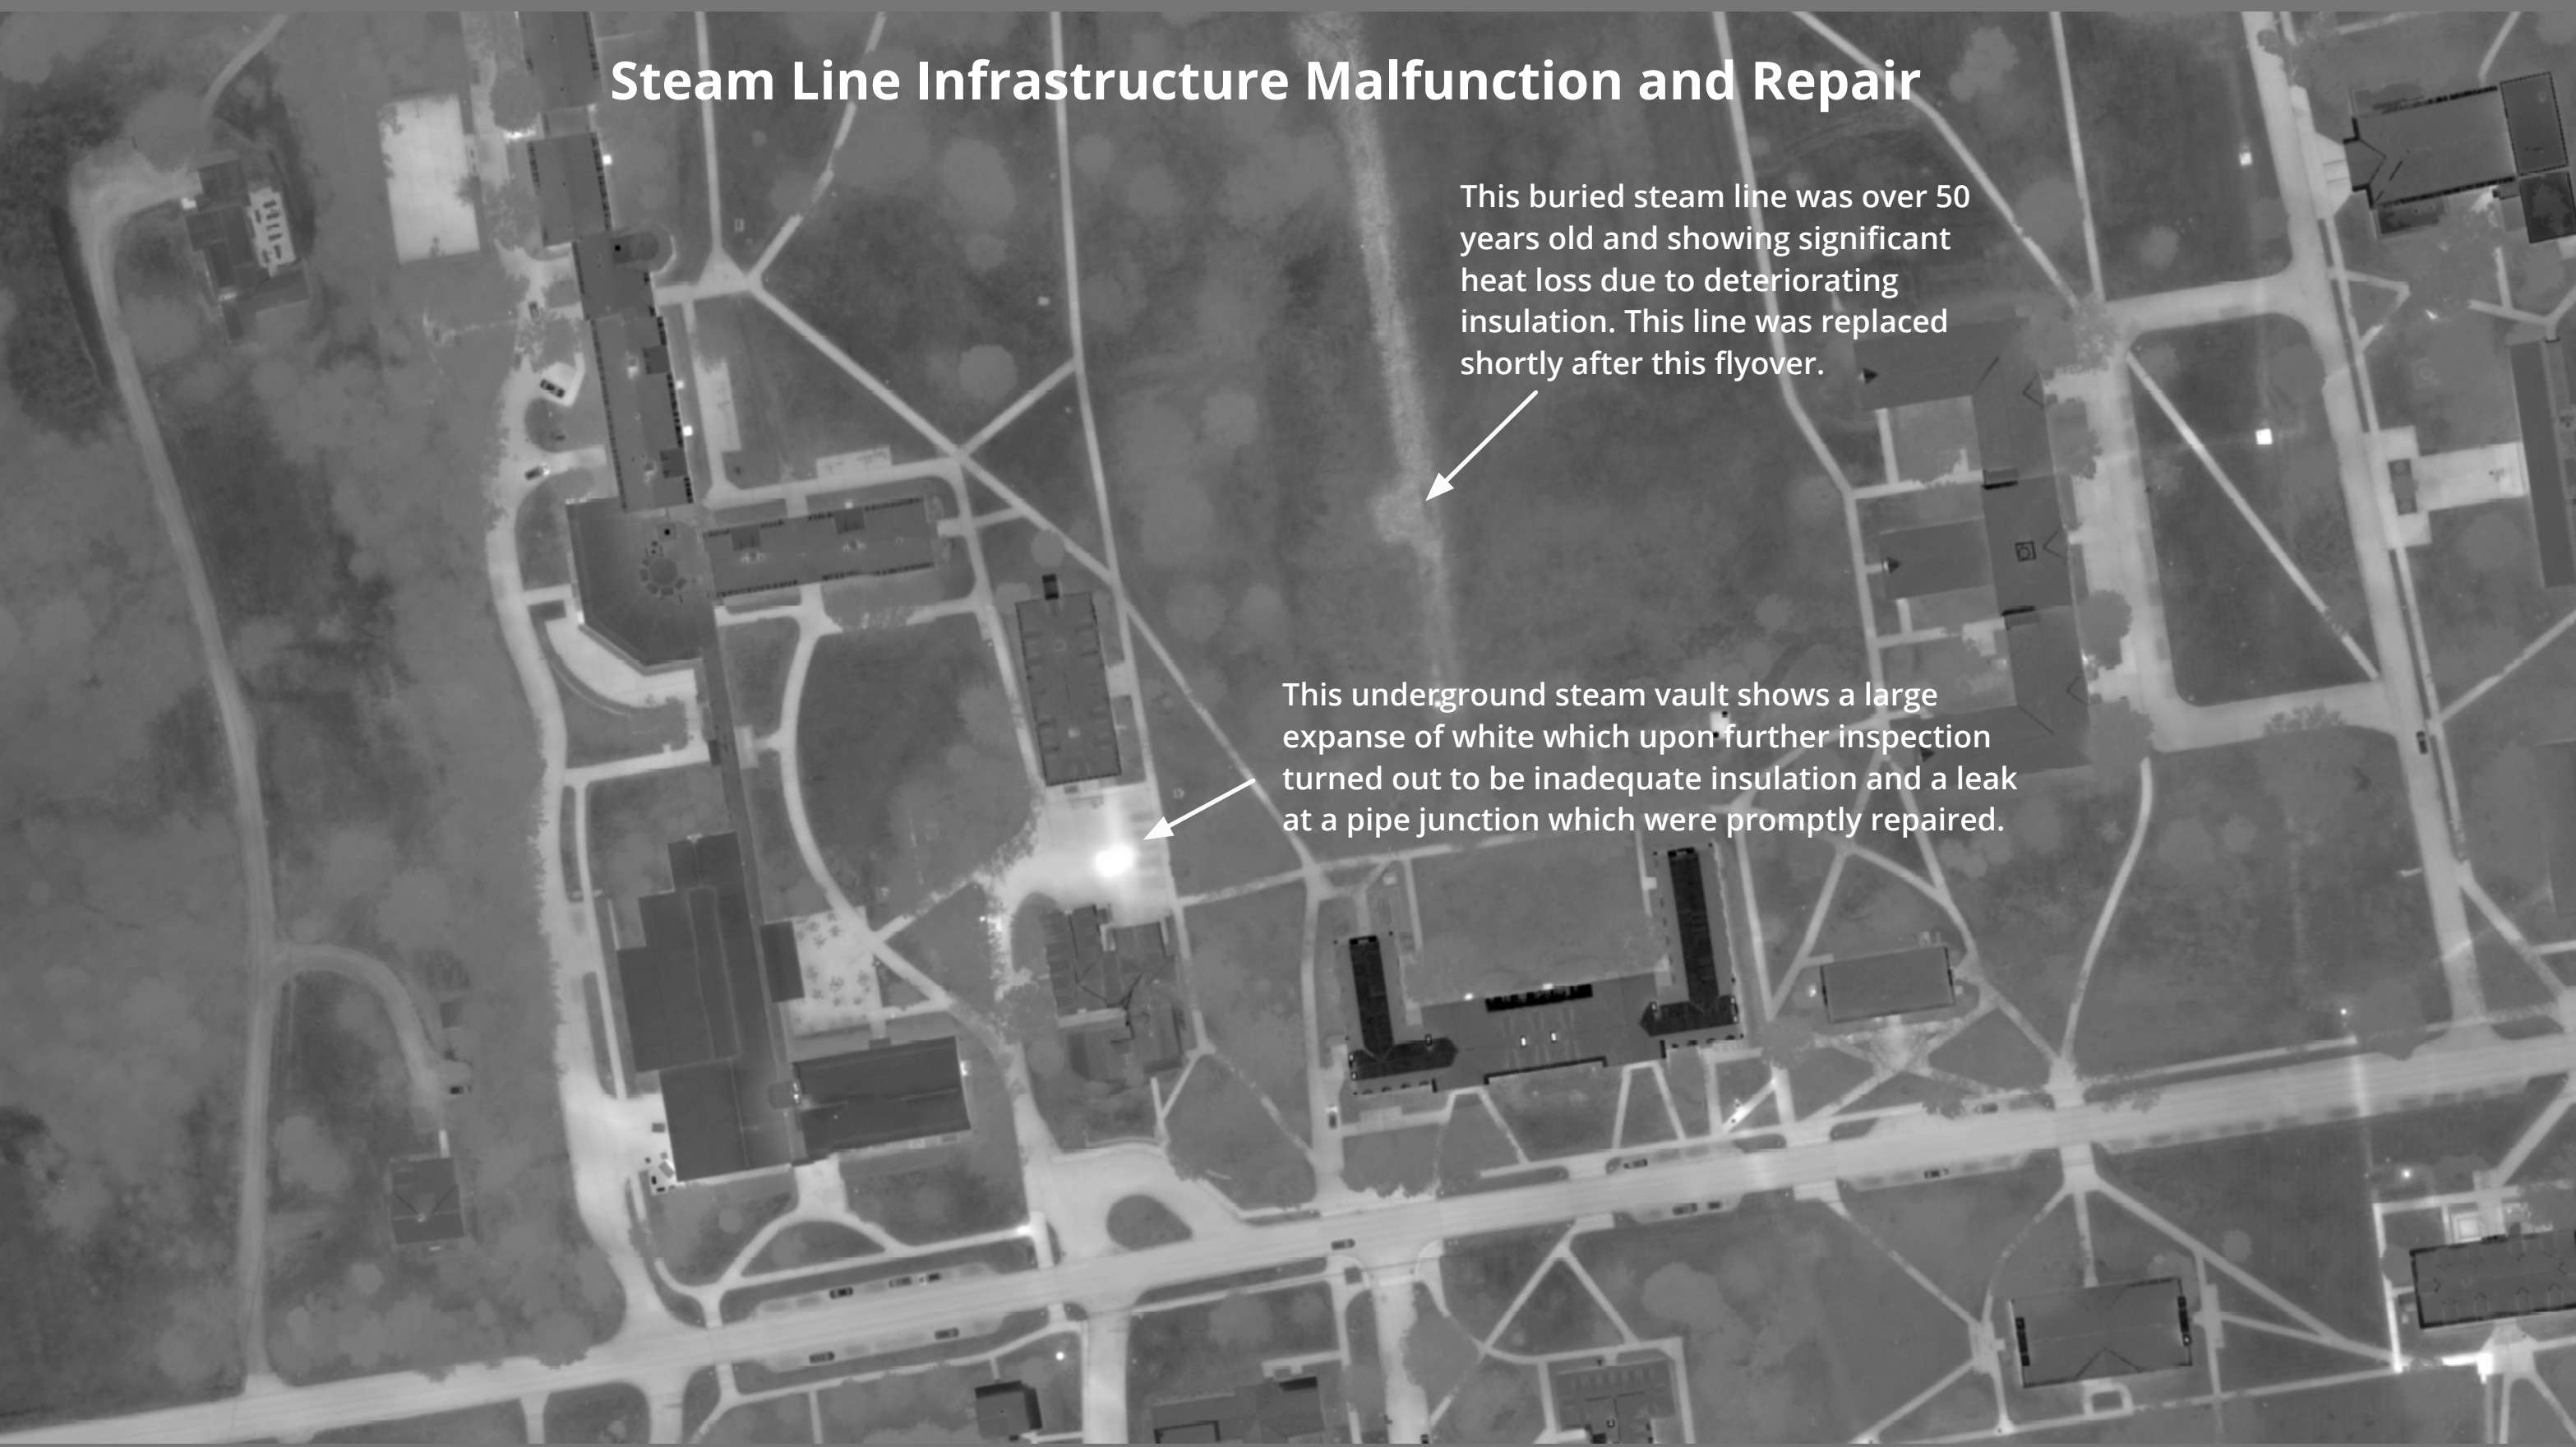
Steam Line Infrastructure Malfunction and Repair

This buried steam line was over 50 years old and showing significant heat loss due to deteriorating insulation. This line was replaced shortly after this flyover.

This underground steam vault shows a large expanse of white which upon further inspection turned out to be inadequate insulation and a leak at a pipe junction which were promptly repaired.
