Infrared Flyover of Middlebury Campus June 4, 2019

In general, whiter colors are warmer, darker colors are cooler. Note however that reflective surfaces, like new metal roofs, register as black thus not representative of the actual heat signature of roof.

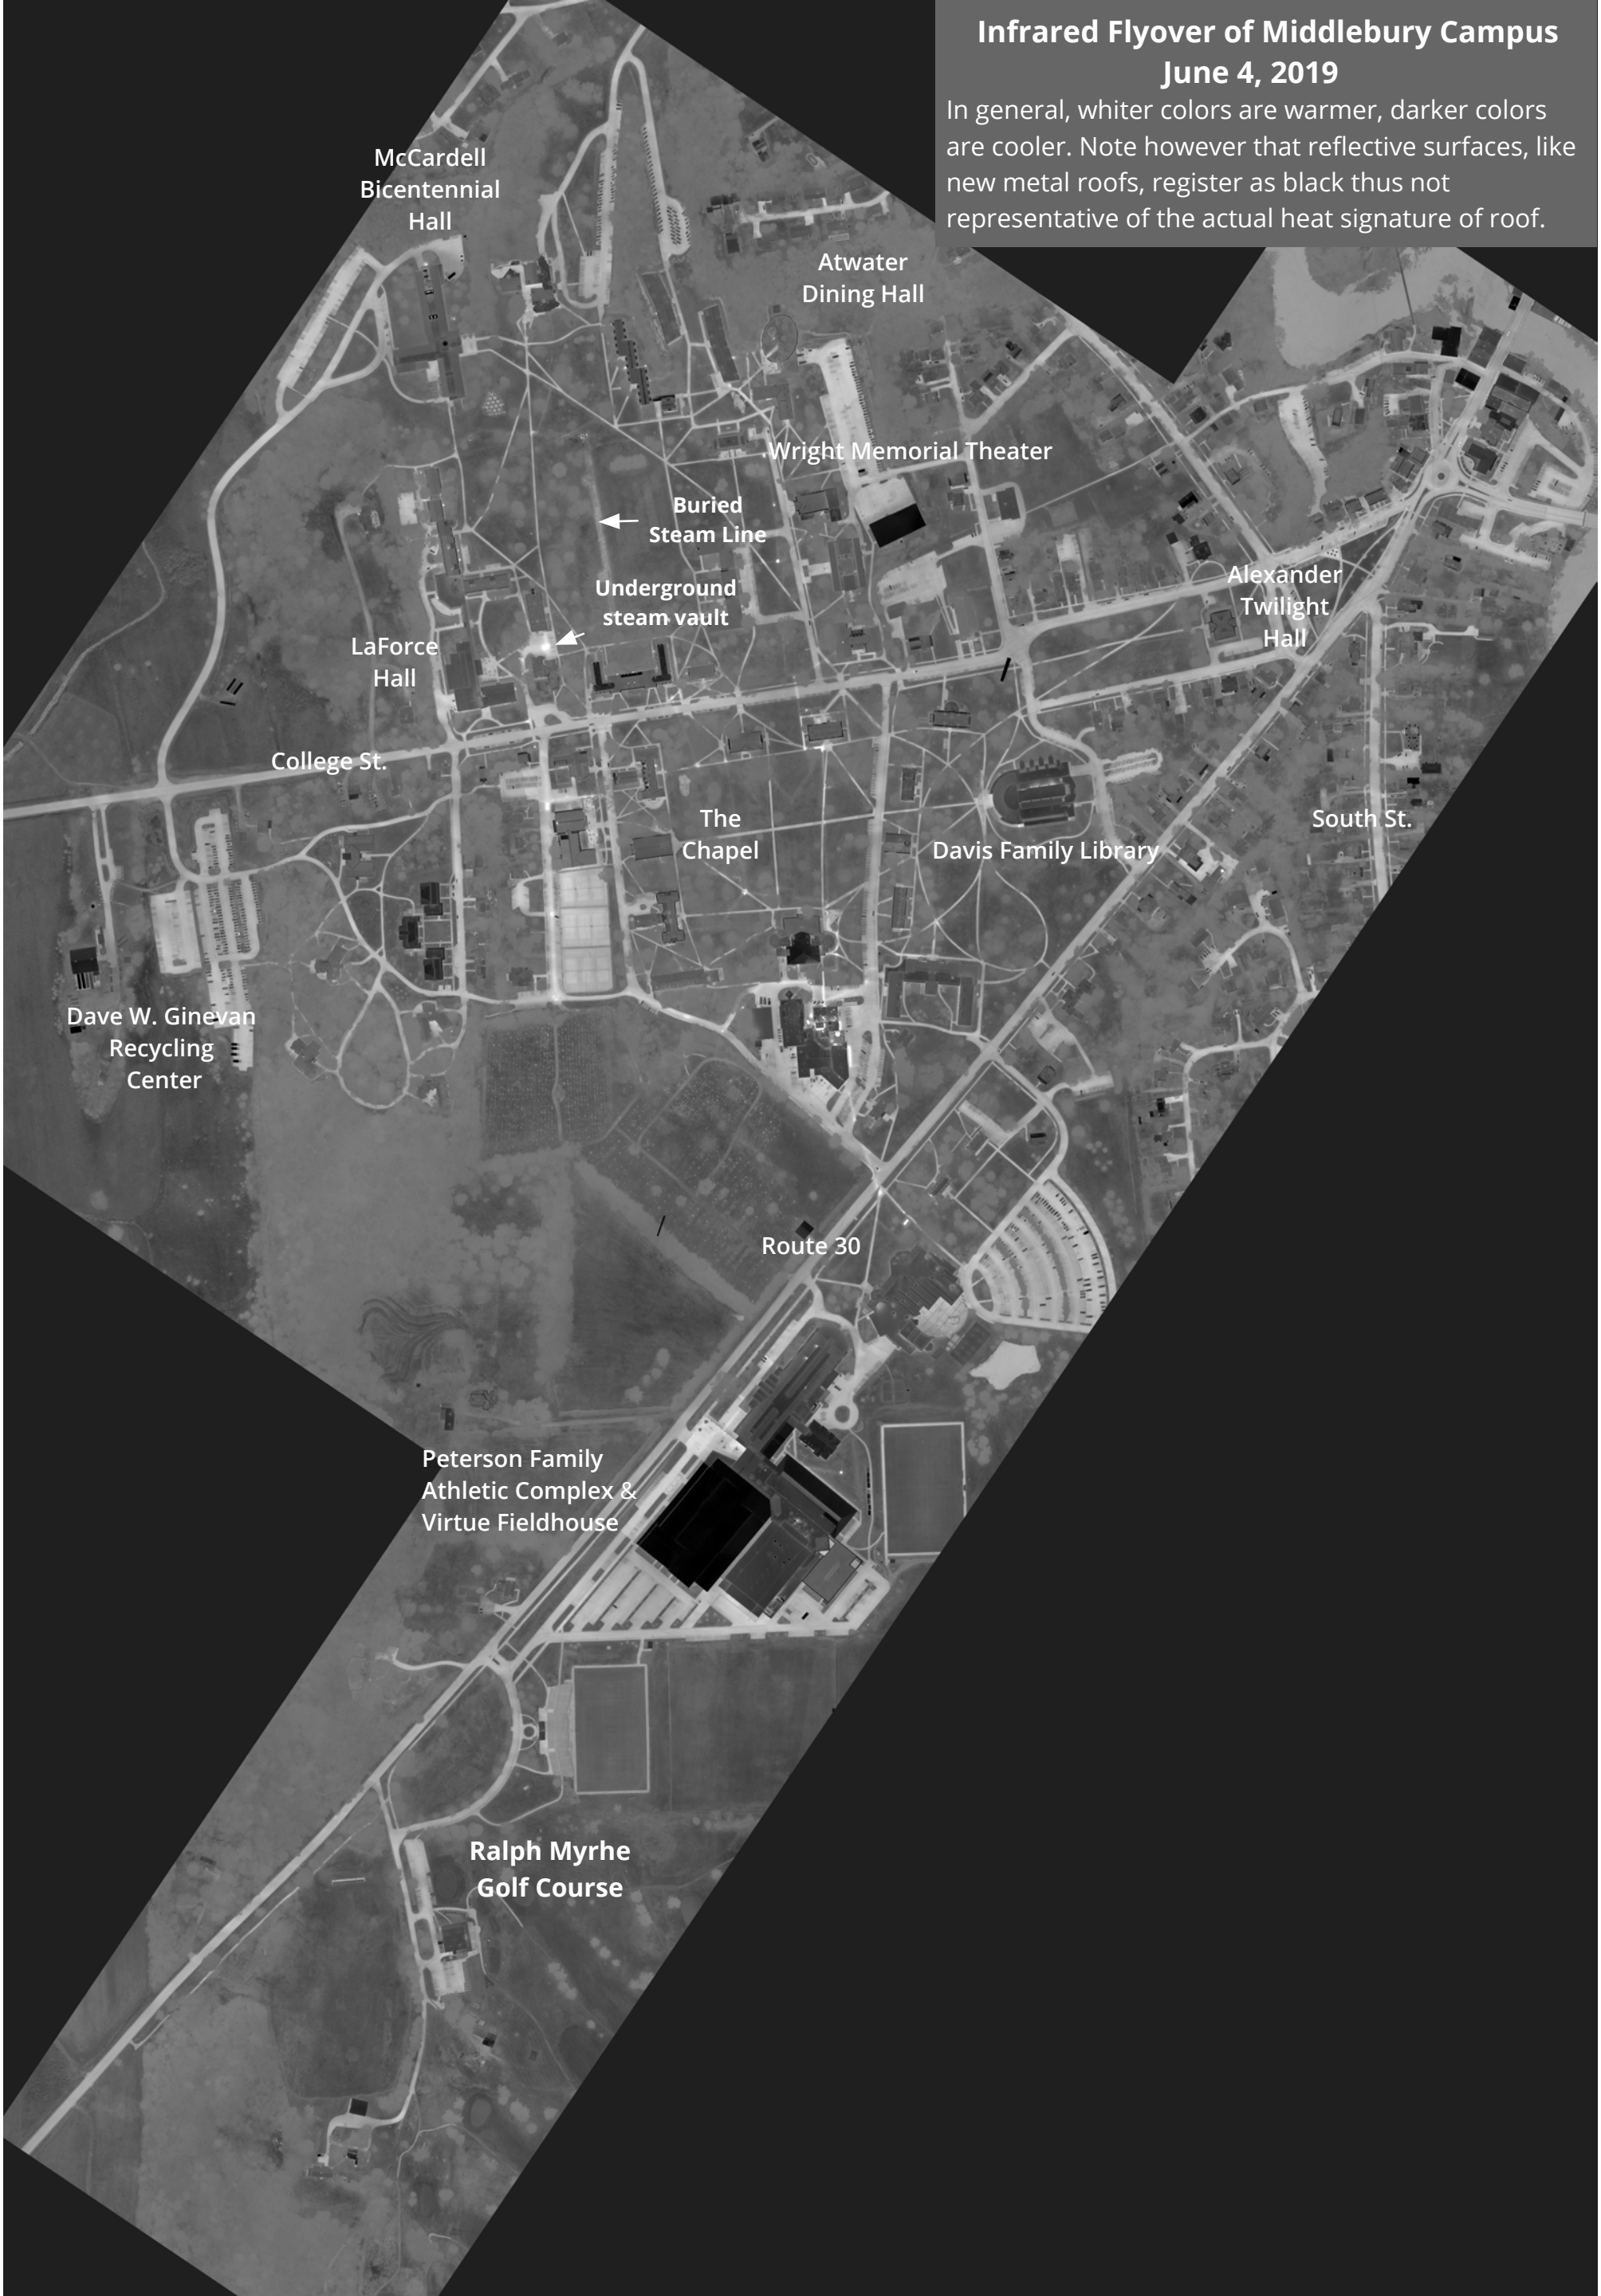
Buried
Steam Line

Underground
steam vault

This buried steam line was over 50 years old and showing significant heat loss due to deteriorating insulation. This line was replaced shortly after this flyover.

This underground steam vault shows a large expanse of white which upon further inspection turned out to be inadequate insulation and a leak at a pipe junction which were promptly repaired.
